W7500x Errata Sheet

Document History

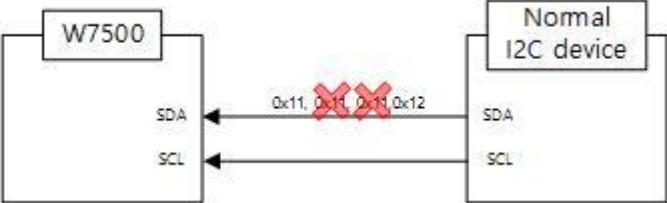
Erratum 1	
Phenomenon	Receiving repeating data in continuative data transmission causes I2C communication problem.
Condition

<p>W7500 receives the first repeating data but starts to discards from the 2nd repeating data to next different data in continuative data transmission. It causes data loss.</p>
Solution & Recommendation	<p>To avoid this issue, W7500 uses GPIO instead of I2C. In this case, SCL has limited speed, 100KHz.</p> <p>Example pseudo code:</p> <pre> Function Initialize_I2C () { ... scl_port_num = I2C_PORT(conf->scl); scl_pin_index = I2C_PIN_INDEX(conf->scl); sda_port_num = I2C_PORT(conf->sda); sda_pin_index = I2C_PIN_INDEX(conf->sda); //SCL setting GPIO_InitDef.GPIO_Pin = scl_pin_index; GPIO_InitDef.GPIO_Mode = GPIO_Mode_OUT; if(scl_port_num == 0) { GPIO_Init(GPIOA, &GPIO_InitDef); GPIO_SetBits(GPIOA, scl_pin_index); } ... //SDA setting </pre>

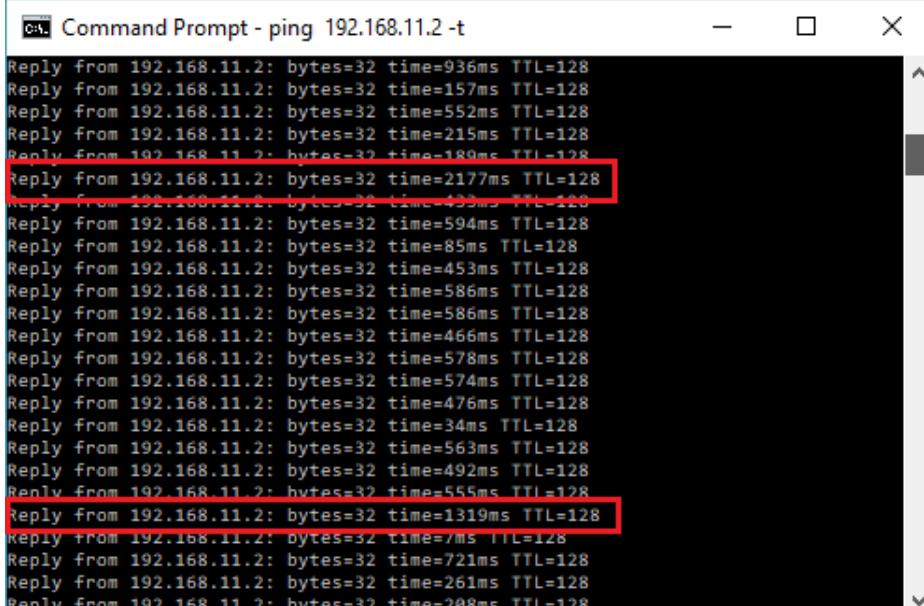
Erratum 2	
Transmission Delay Case	
Phenomenon	<p>There are some cases of data transmission delay when W7500P is connected to a particular switch/router.(The router that was used for the below test is "TP_LINK AC750")</p>

<p>As shown above, there are random cases where the ping reply is delayed over 3 seconds and occurs irregularly.</p>
Condition	<p>The cause of this phenomenon is due to NC(Not Connected) pads & the connection problems related to PHY MII signals inside the chip(W7500P is silicon-in-package product and it includes W7500 and Ethernet PHY circuit inside.); By Collision handling due to wrong detection of duplex mode, the transmission packets are delayed.</p>
Solution & Recommendation	<p>In order to resolve this phenomenon, users MUST add the following initialization code.</p> <pre>void PHY_Init(void) { #ifdef __W7500P__ // W7500P only // PB_12 *(volatile uint32_t *) (0x41003070) = 0x61; // RXDV: set pull down // PB_05 }</pre>

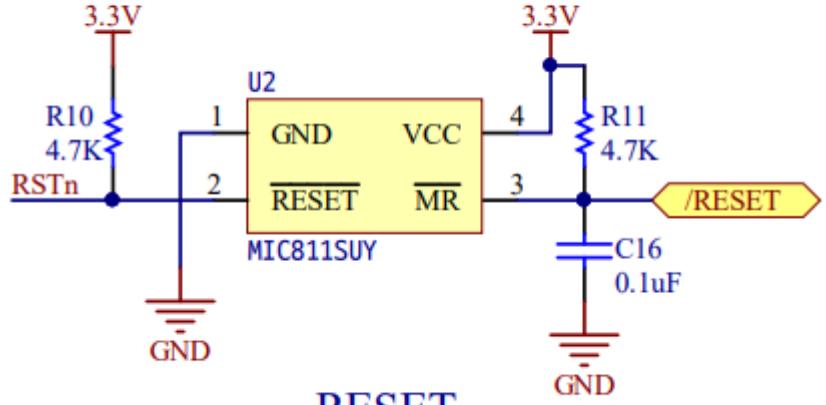
Erratum 5	
Cold Booting Failure	
Phenomenon	Cold booting failure
Condition	If the time that Power supply raises to the operating supply voltage, 2.7V is longer than 20ms or a different phase power source over 1V is supplied to any peripheral pin before Power on, the internal reset logic of the MCU doesn't run and this happens.
Solution & Recommendation	<p>The best solution is to add POR(Power On Reset) chip</p> <p style="text-align: center;">W7500P requires an external Power On Reset (POR) IC.</p>

<p style="text-align: center;">RESET</p> <p>To avoid to add POR, you should guarantee that 0-to-2.7V time is shorter than 20ms and peripheral pins are isolated from external power source.</p> <p>For reference,</p> <p>https://github.com/Wiznet/Hardware-Files-of-WIZnet/tree/master/01_iMCU/W7500P/Reference%20Schematic</p>
